Manhole Inspection Summary

Manhole # S25S__003MH

Insp Date: **4/11/08 10:18 AM**

Location Address: **1500 WICOMICO ST.**

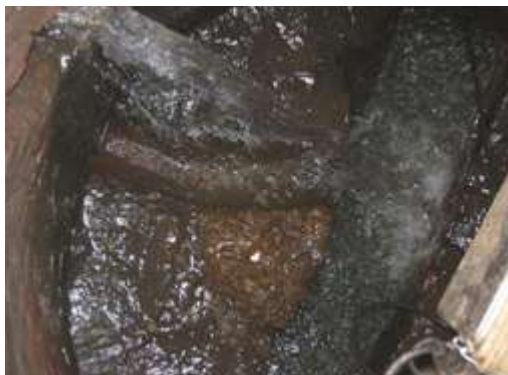
Defect 4

Condition: ☐ Sound ☐ Cracked ☐ Root Intrusion ☒ Deteriorated ☐ Leaks ☐ Debris

DETERIORATED BENCH

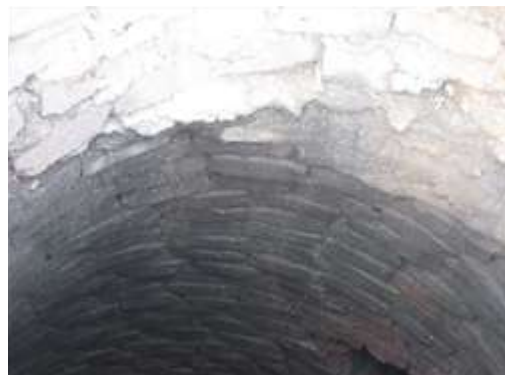
Defect 3

Infiltration: ☐ None ☐ Joint ☐ Cracks ☐ Mortar ☐ Roots ☒ Wall

EVIDENCE OF CORBEL INFILTRATION
BECAUSE OF MISSING MORTAR

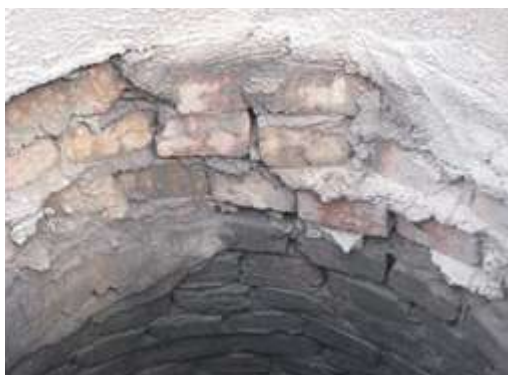
Defect 1

Infiltration: ☐ None ☐ Joint ☐ Cracks ☒ Mortar ☐ Roots ☐ Wall

EVIDENCE OF CHIMNEY
INFILTRATION, MISSING MORTAR

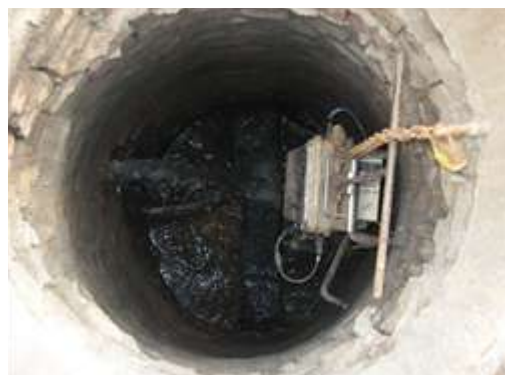
Defect 5

Count: **4** Missing: **0** ☒ Corroded

corroded steps

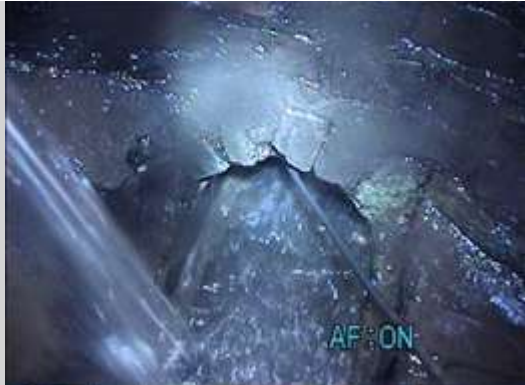
12 O'Clock Outflow

Pipe Height: **10.8** (in.) Rod and Bar (Angled)
Pipe Material: **Clay** ☐ Pipe Lined
Invert Depth: **9.43** (ft.) Flow Characteristics: **Fast**
Deposits: ☒ None ☐ Mud ☐ Sludge ☐ Debris ☐ Grease
Silt Depth: **0** (in.) Deposits Extent:
Infiltration: **Evidence** Pipe Seal Cond: **Broken**

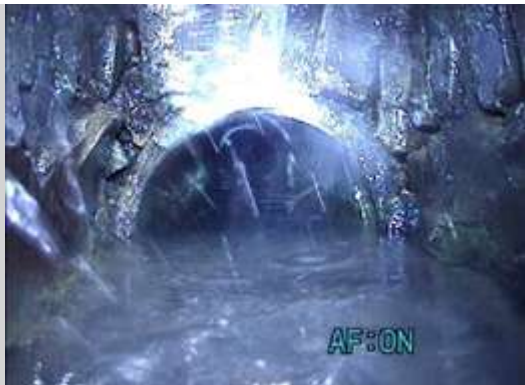
6 O'Clock Inflow

Pipe Height: **8.4** (in.) Rod and Bar (Angled)
Pipe Material: **Clay** ☐ Pipe Lined
Invert Depth: **9.55** (ft.) Flow Characteristics: **Slow**
Deposits: ☒ None ☐ Mud ☐ Sludge ☐ Debris ☐ Grease
Silt Depth: **0** (in.) Deposits Extent:
Infiltration: **Evidence** Pipe Seal Cond: **Unknown**

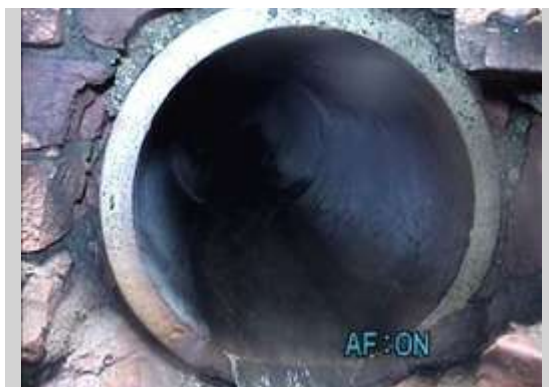
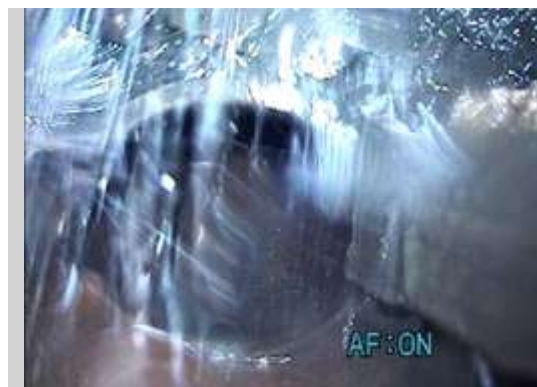
9 O'Clock Inflow

Infiltration: **Evidence**

Drop: Outside	Rod and Bar
Angled: Yes	Reading: 7.38 (ft.)
	Inv Depth: 8.38 (ft.)
Drop Condition: Open
